Debris/Ice/TPS Assessment and Integrated Photographic Analysis of Shuttle Mission STS-72

**DEBRIS/ICE/TPS ASSESSMENT
AND
INTEGRATED PHOTOGRAPHIC ANALYSIS
OF
SHUTTLE MISSION STS-72**

11 January 1996

**NASA, Lockheed-Martin, Rockwell, and Thiokol Members of the
Debris/Ice/TPS and Photographic Analysis Teams**

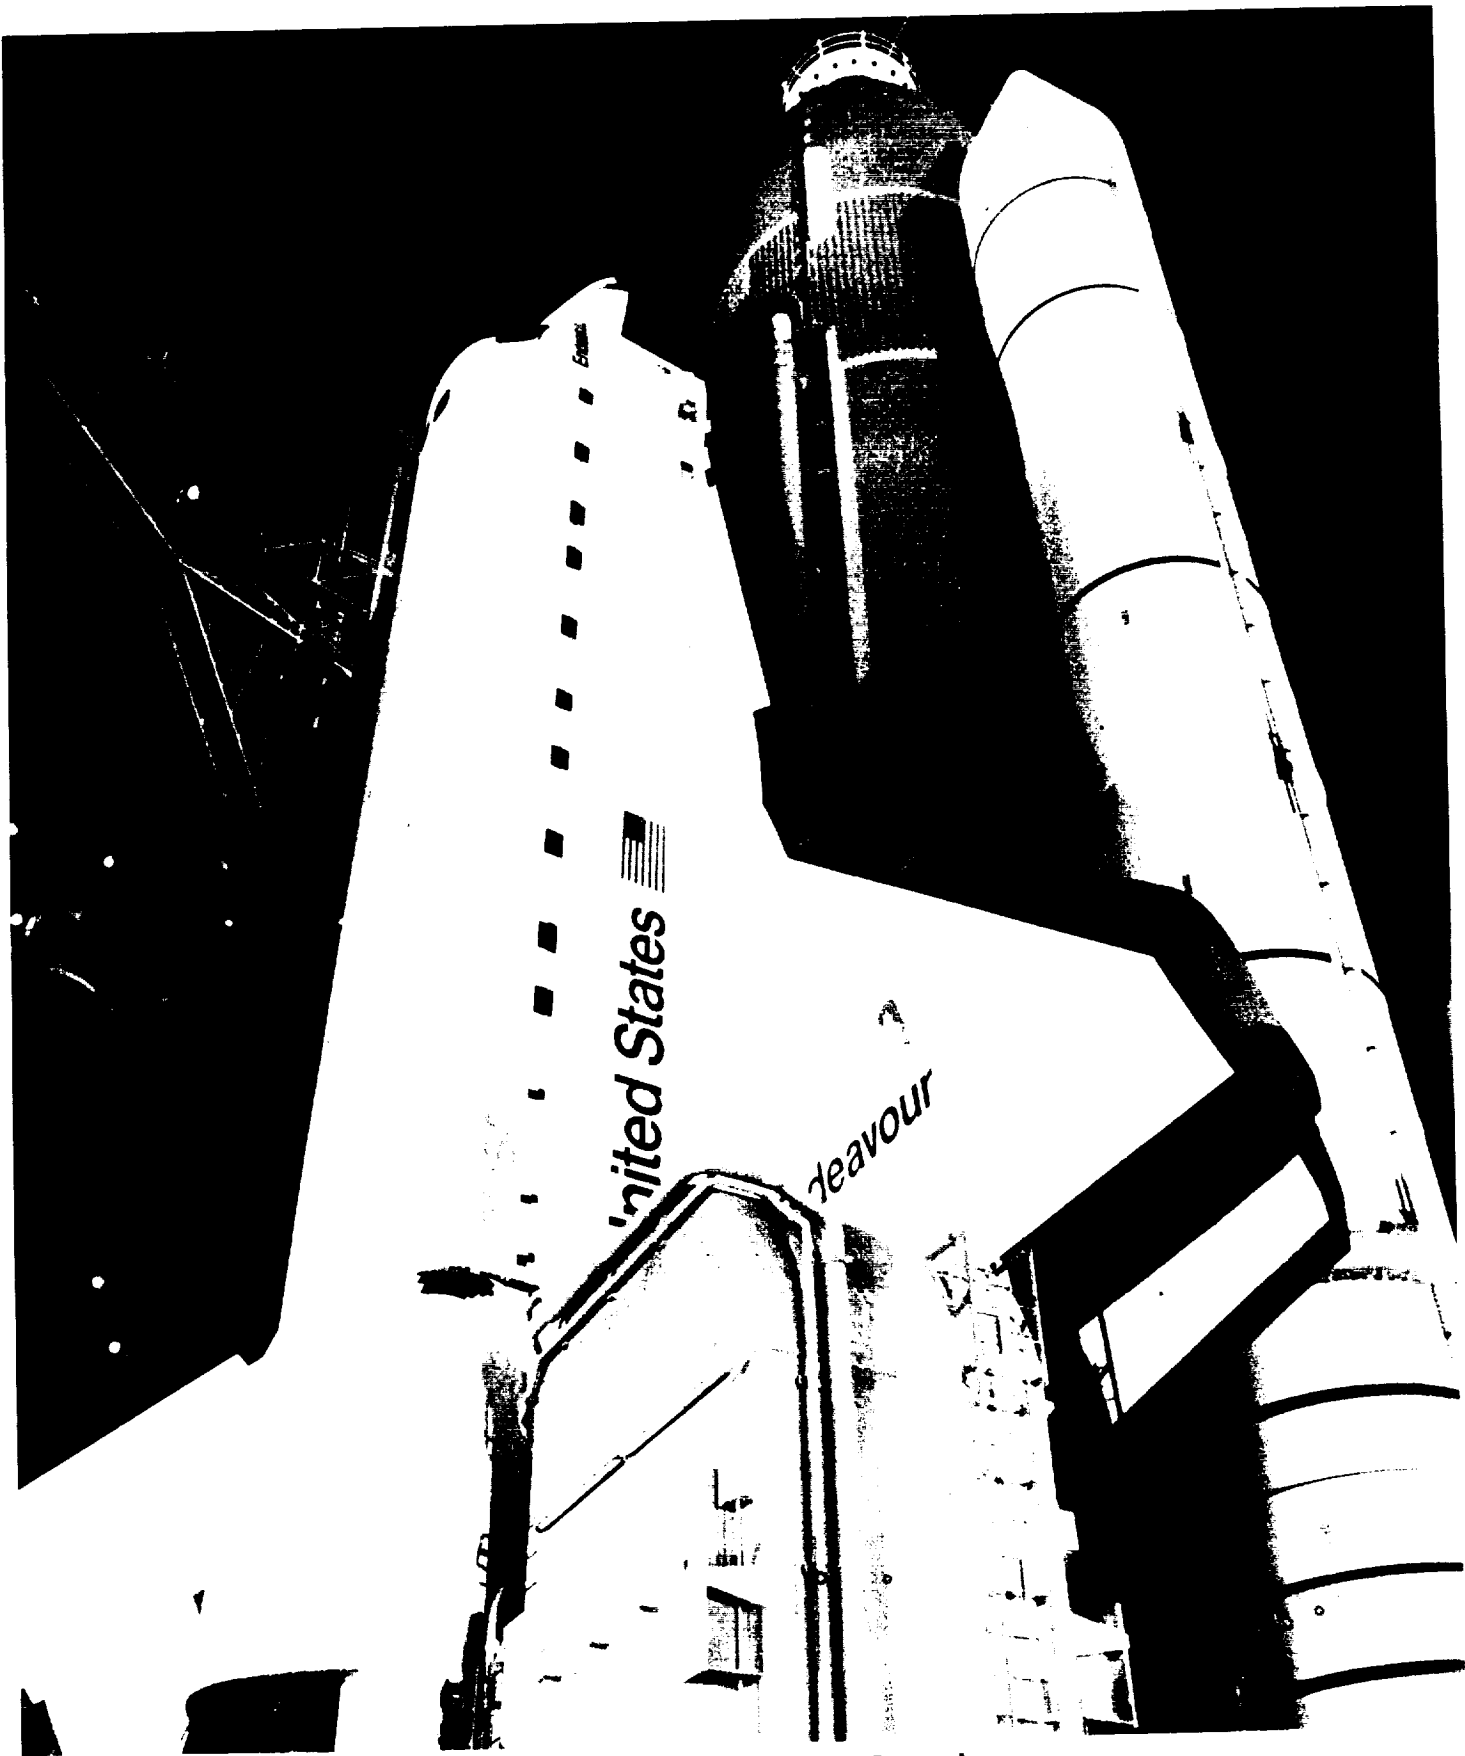
Photo 2: ET-75 Cryoloaded for Launch

The Final Inspection Team observed dry TPS on the LO₂ tank ogive. Very light condensate and frost, but no detectable ice, had accumulated on the LO₂ tank barrel and LH₂ tank acreage +Y+Z quadrant.

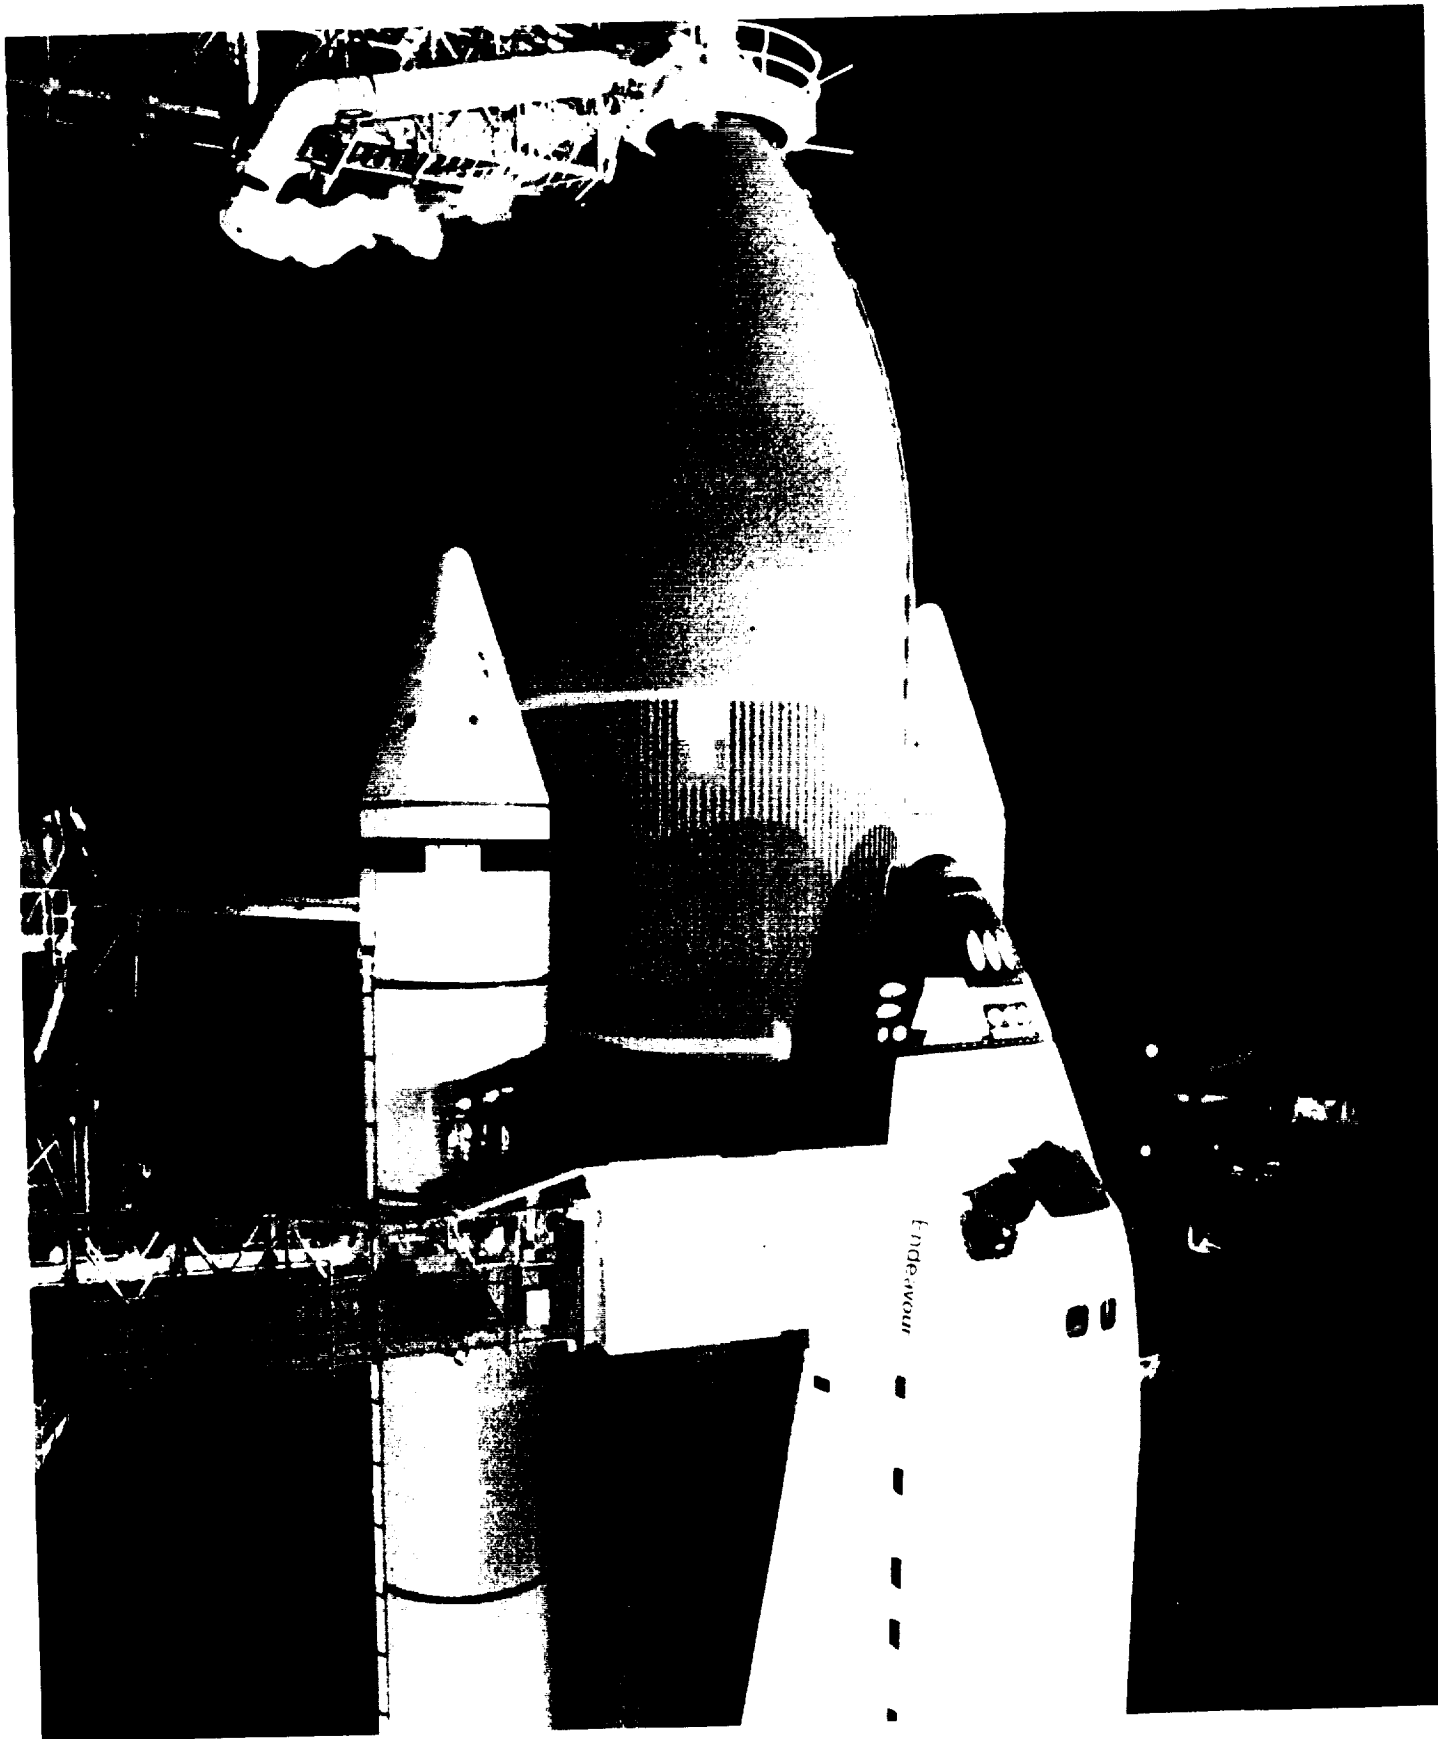
Photo 4: ET Intertank and LO2 Tank Barrel After Cryoload

The intertank acreage exhibited no TPS anomalies. The portable STI and Raytek measured an average surface temperature of 50 degrees F on the intertank. Very light condensate and frost, but no detectable ice, accumulated on the LO2 tank barrel +Y+Z quadrant.

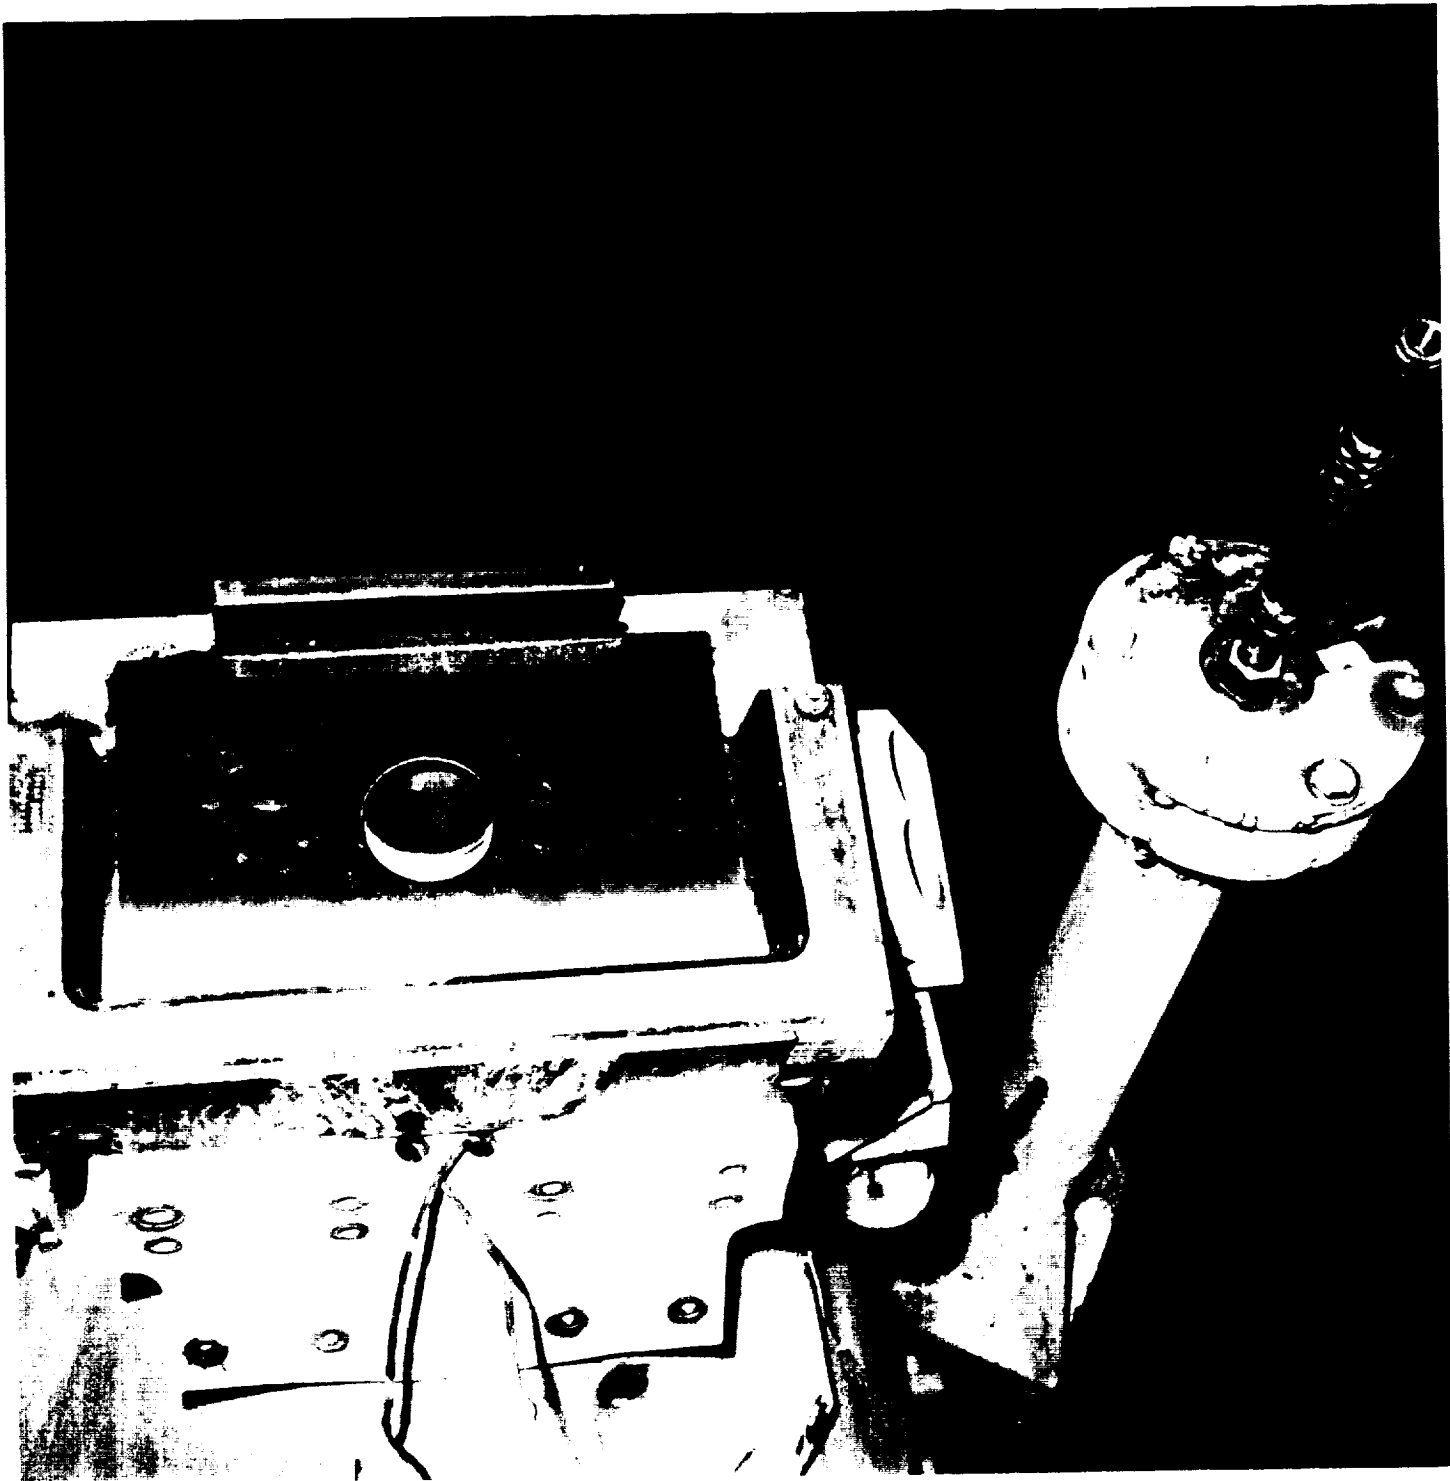
Photo 10: Aft Skirt Shoe Shim

Although the aft skirt shoe shim material was intact, the new material, which is somewhat darker than the material used prior to BI-074, exhibited a bubbled appearance after launch

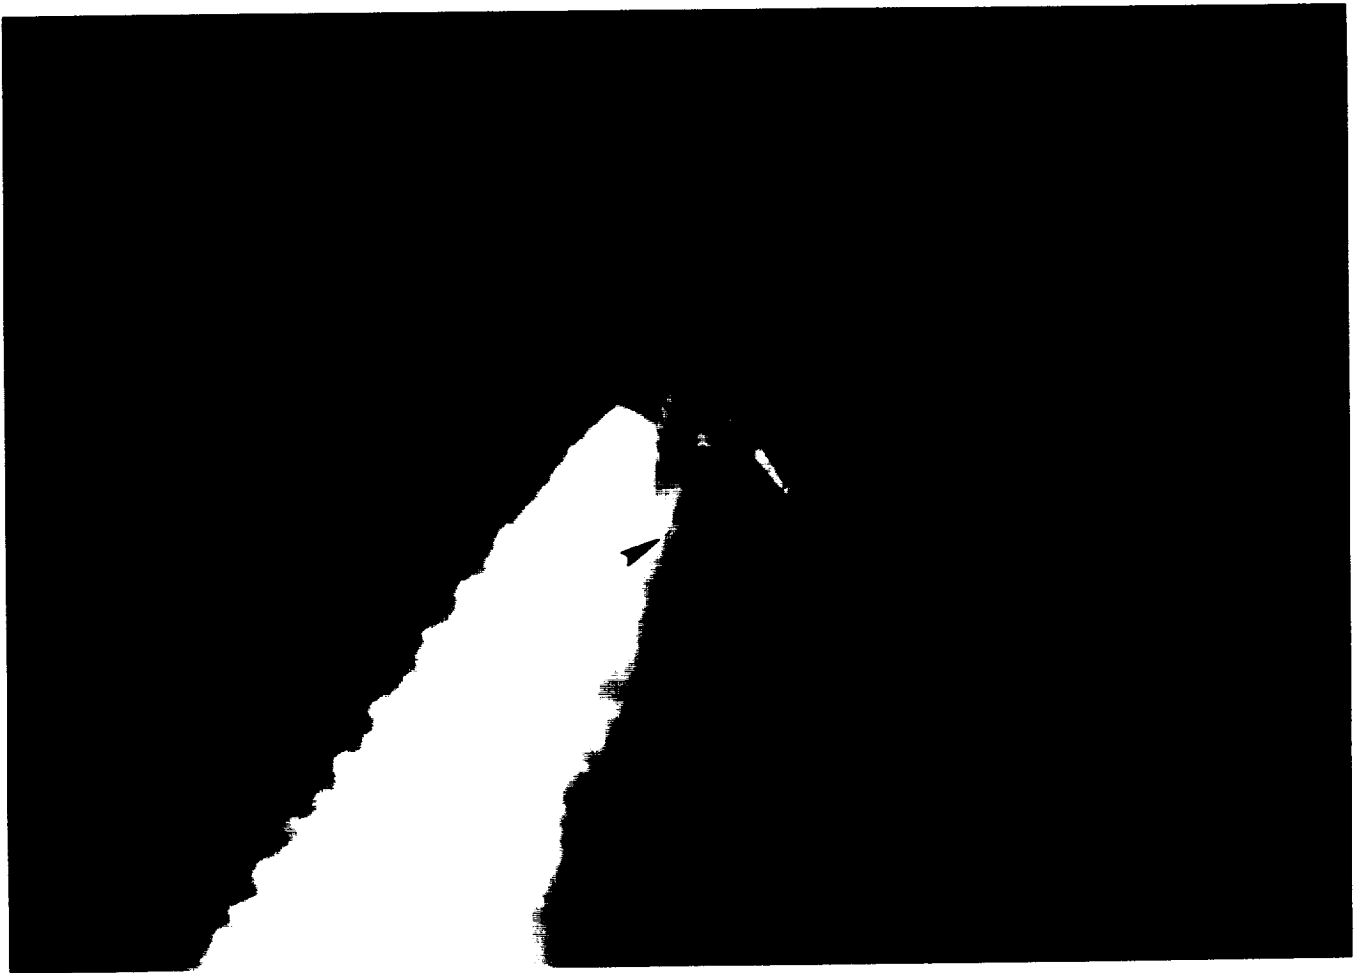
Photo 11: Flame in Engine Plume

A flare, or long streak, was visible in the SSME plume during ascent at T+22 seconds MET

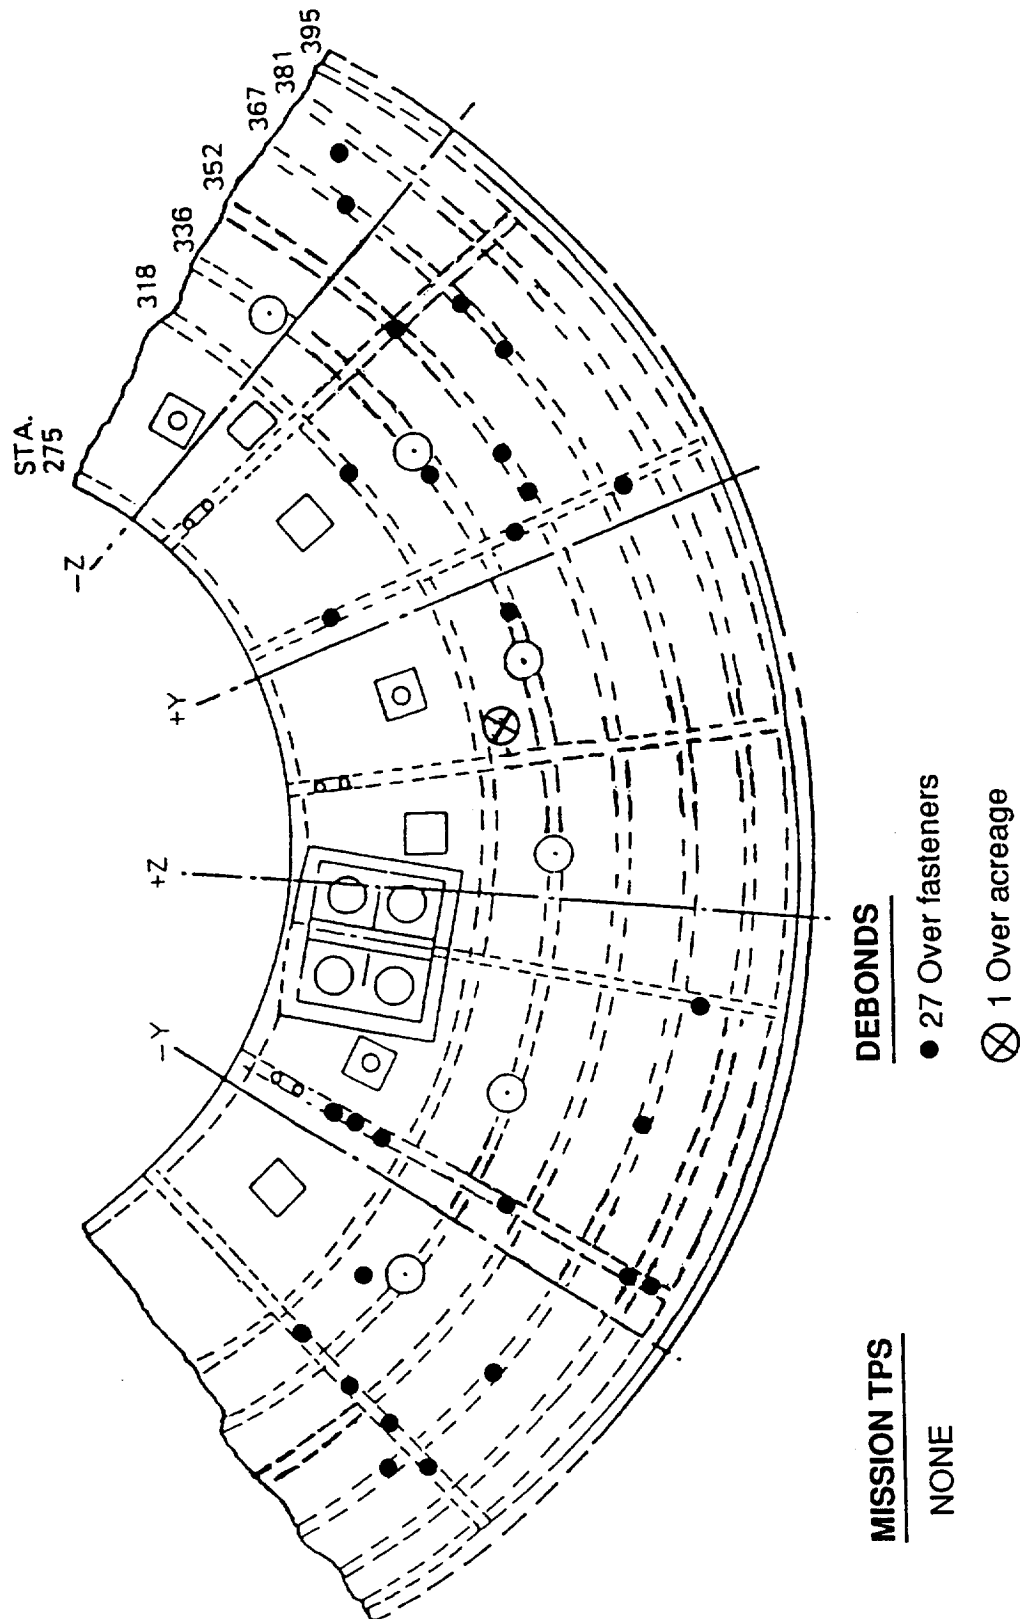
Figure 4: RH SRB Frustum

The RH frustum was missing no TPS. The number of debonds over fasteners (27) and over acreage (1) was close to the average (Figure 4). Hypalon paint was blistered/missing along the XB-395 ring frame where BTA closeouts had been applied. However, most of the exposed BTA substrate was not sooted. The BSM aero heat shield covers had locked in the fully opened position though the two lower cover attach rings had been bent slightly by parachute riser entanglement.

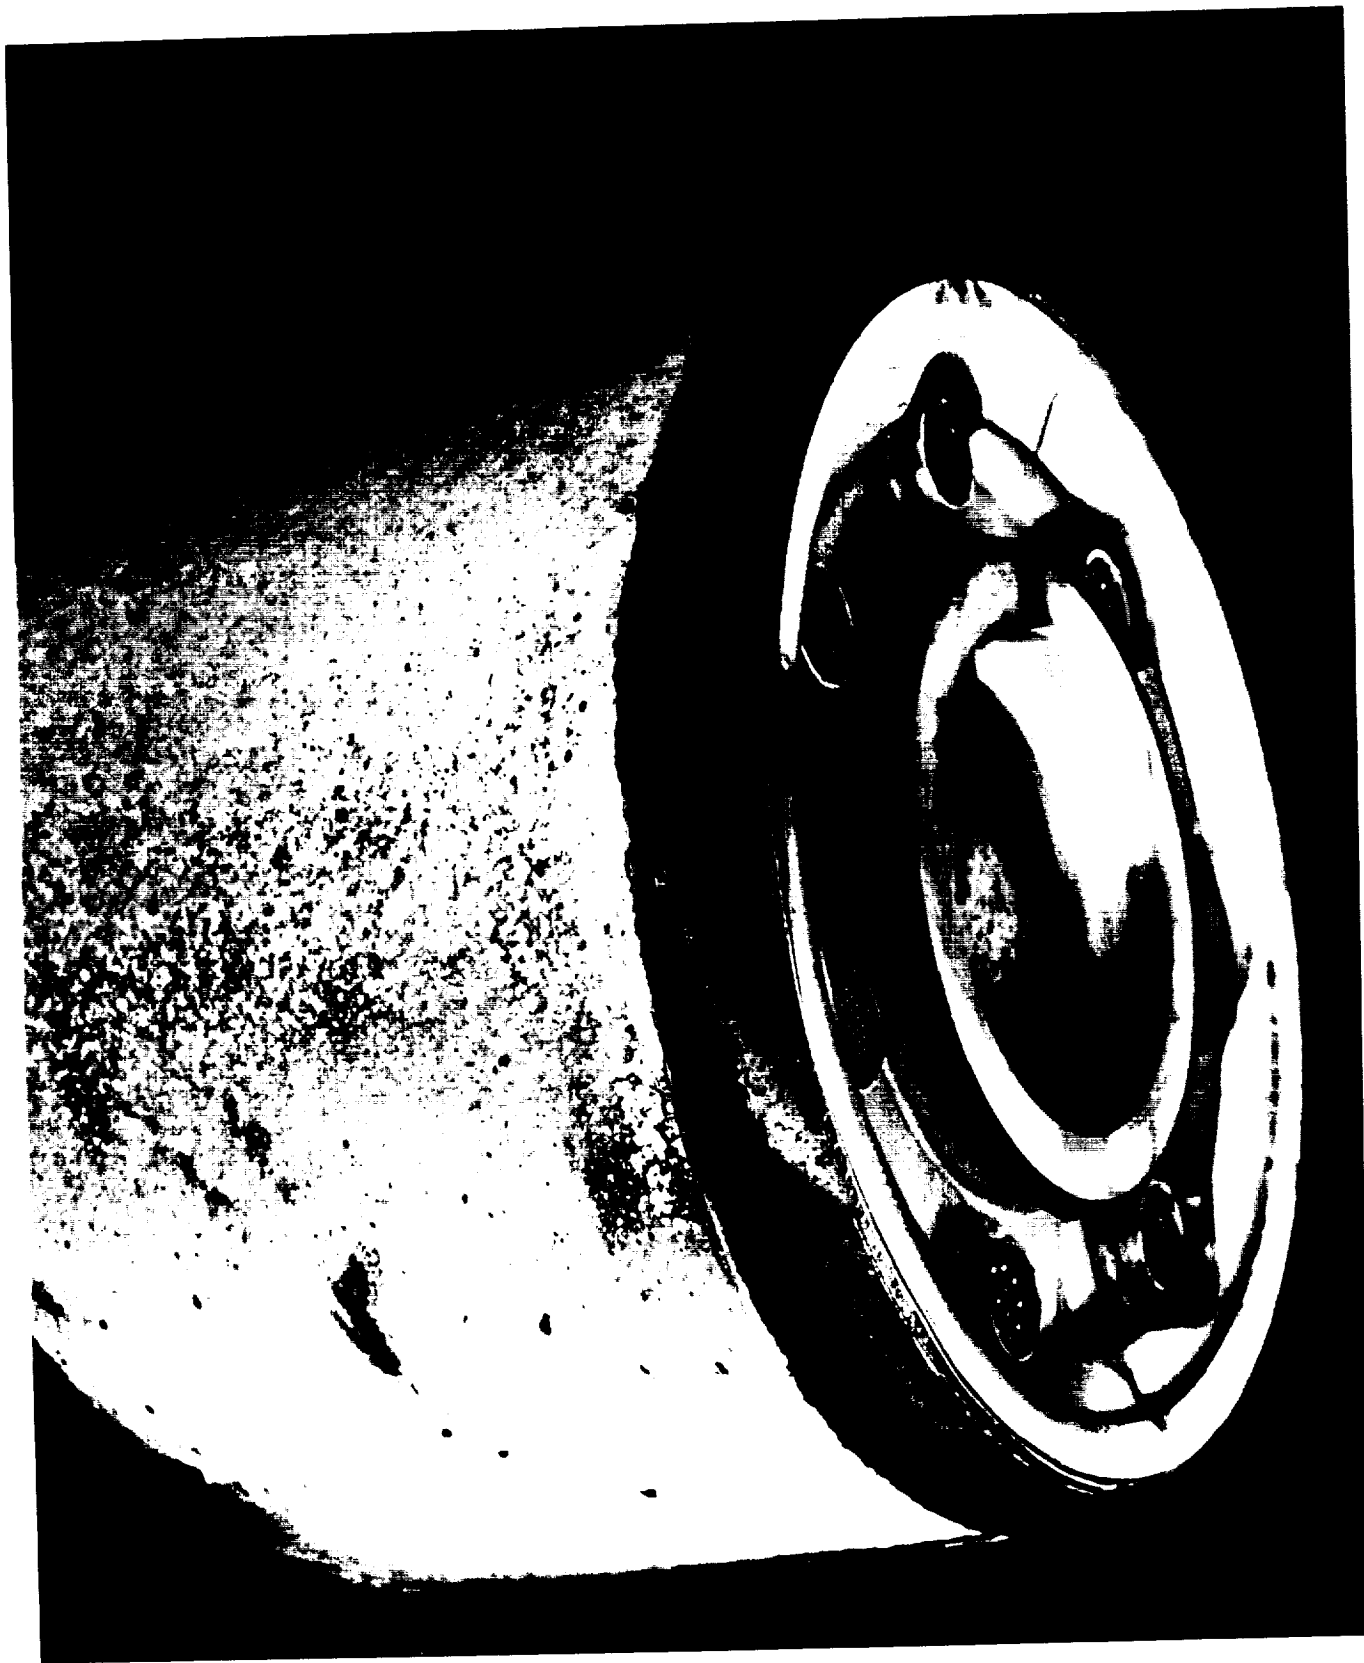
Photo 15: Upper Strut Fairing Missing K5NA

Separation of the aft ET/SRB struts appeared normal. K5NA 3-inches long by 1-inch wide was missing from the separation plane of the upper strut fairing.

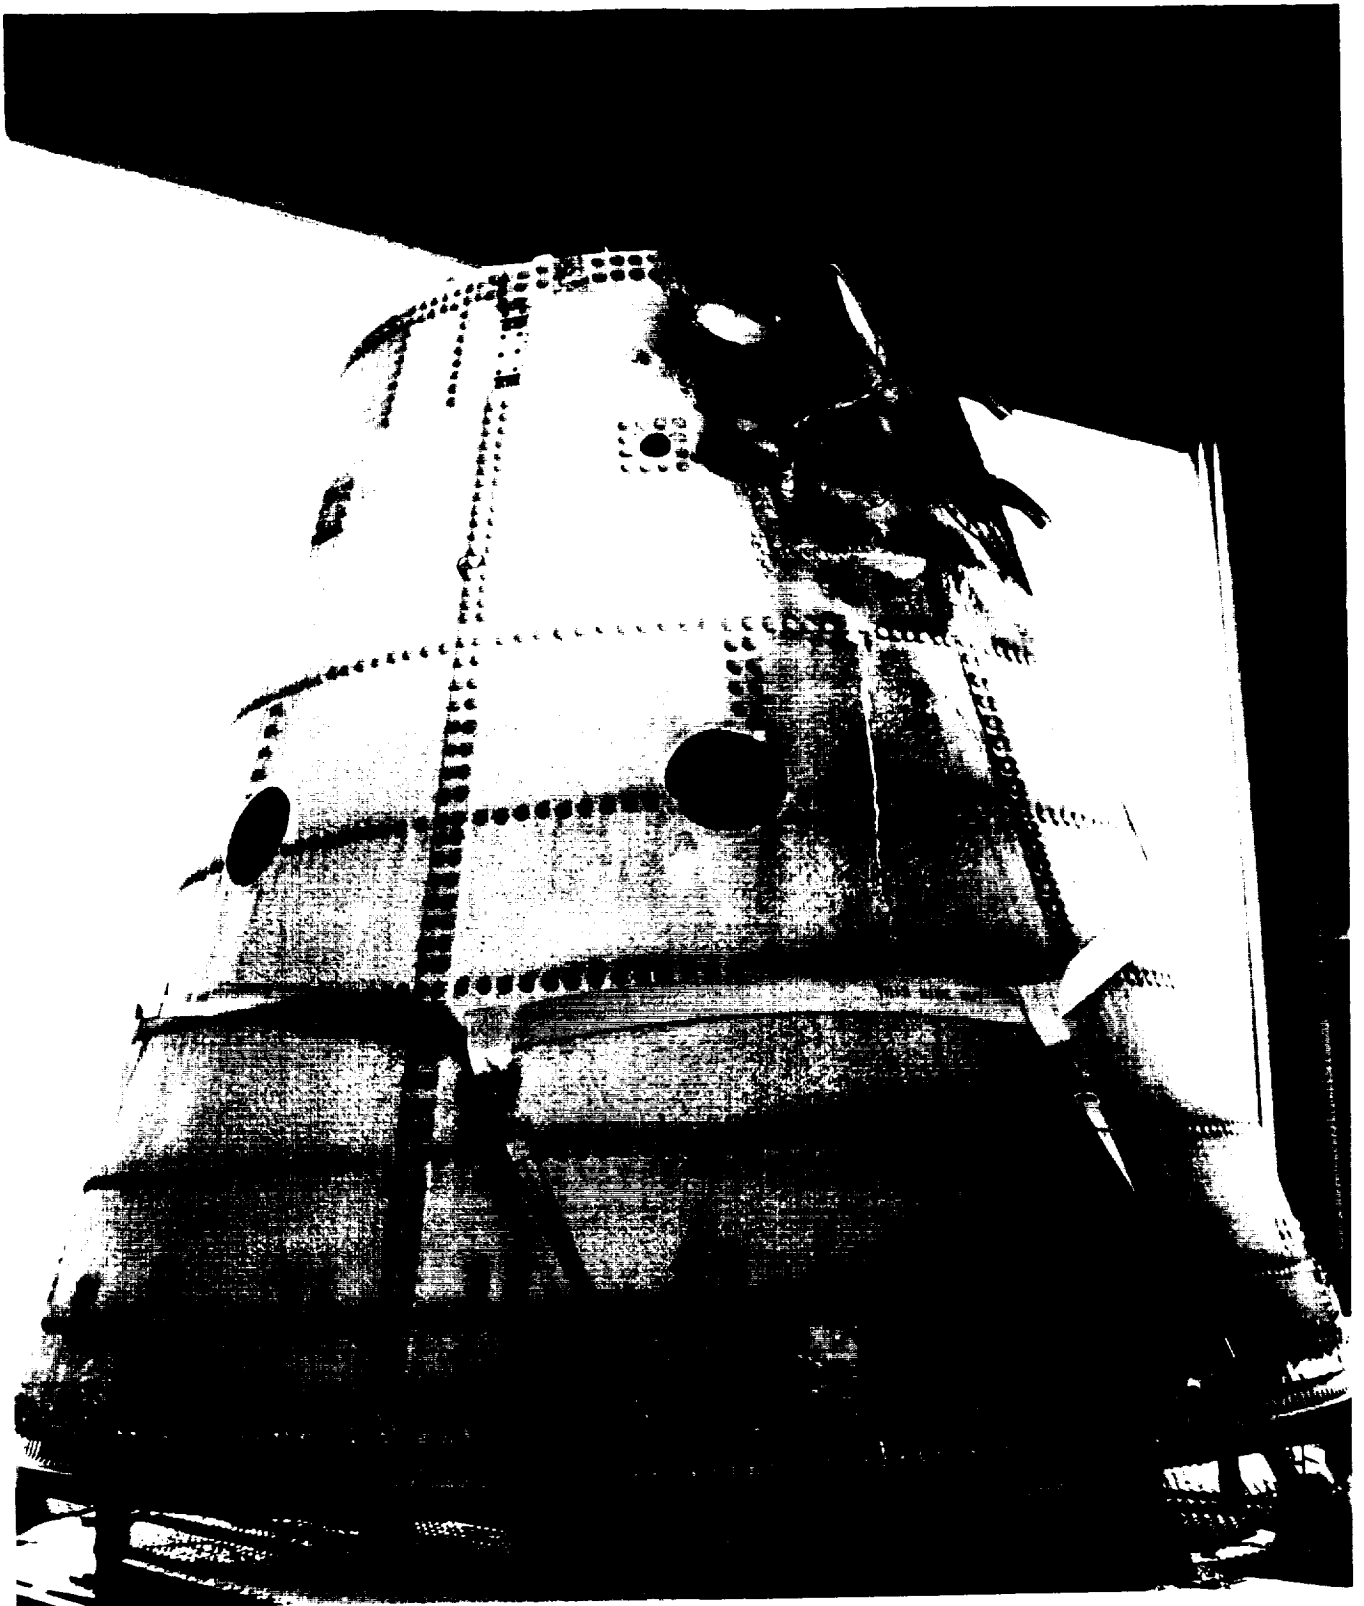
Photo 17: LH Frustum

The LH frustum was missing no TPS. The number of MSA-2 debonds over fasteners (36) was average. Hypalon paint was blistered/missing along the XB-395 ring frame where BTA closeouts had been applied. However, most of the exposed BTA substrate was not sooted. The BSM aero heat shield covers had locked in the fully opened position.

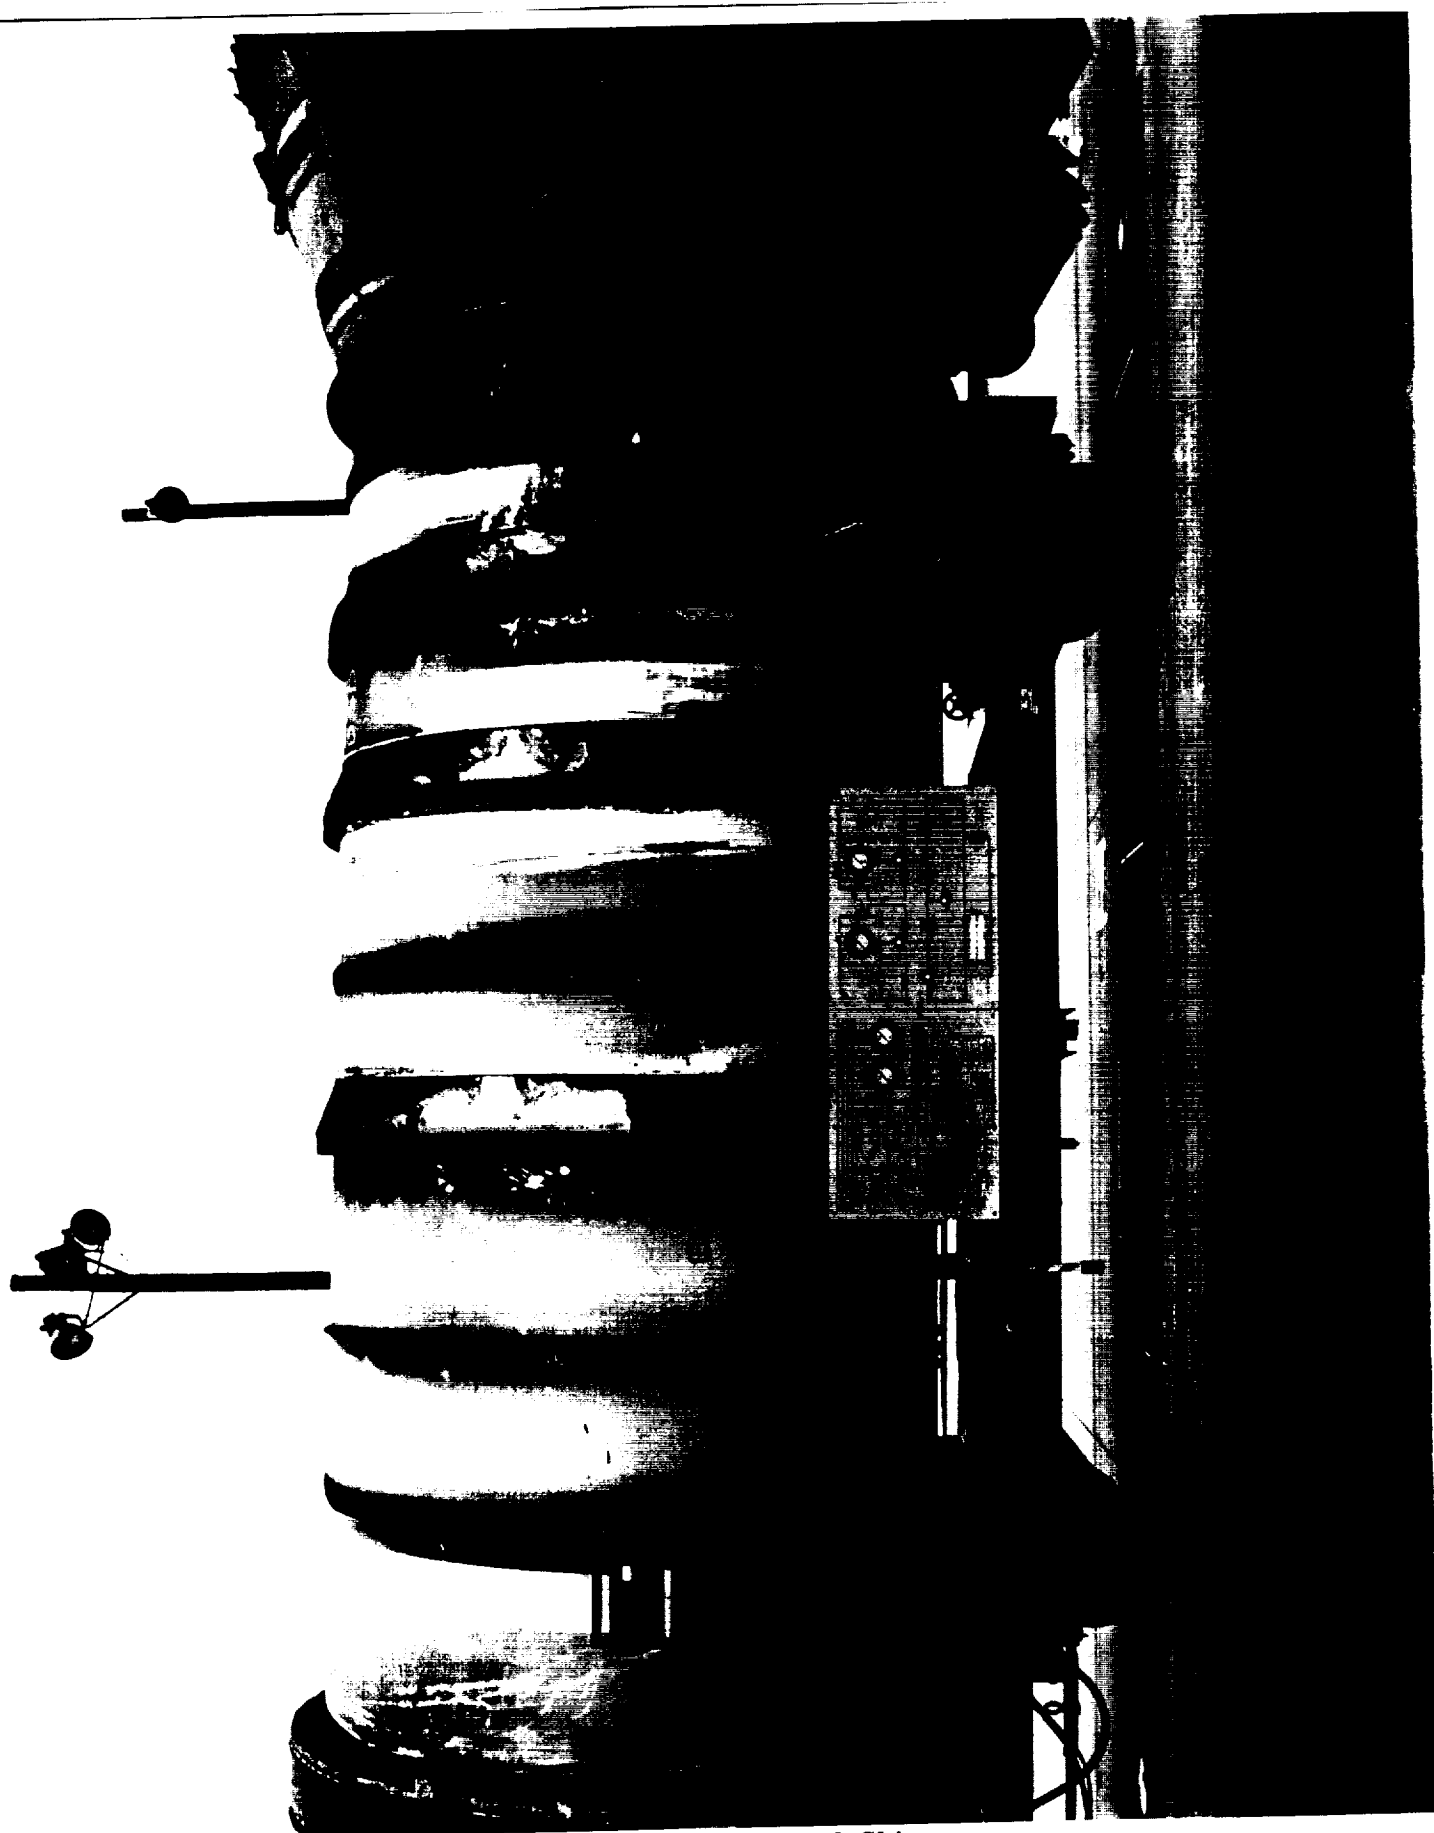
Photo 19: LH Aft Booster/ Aft Skirt

Aft skirt MSA-2 was intact. The HDP Debris Containment System (DCS) plungers were seated and appeared to have functioned properly.

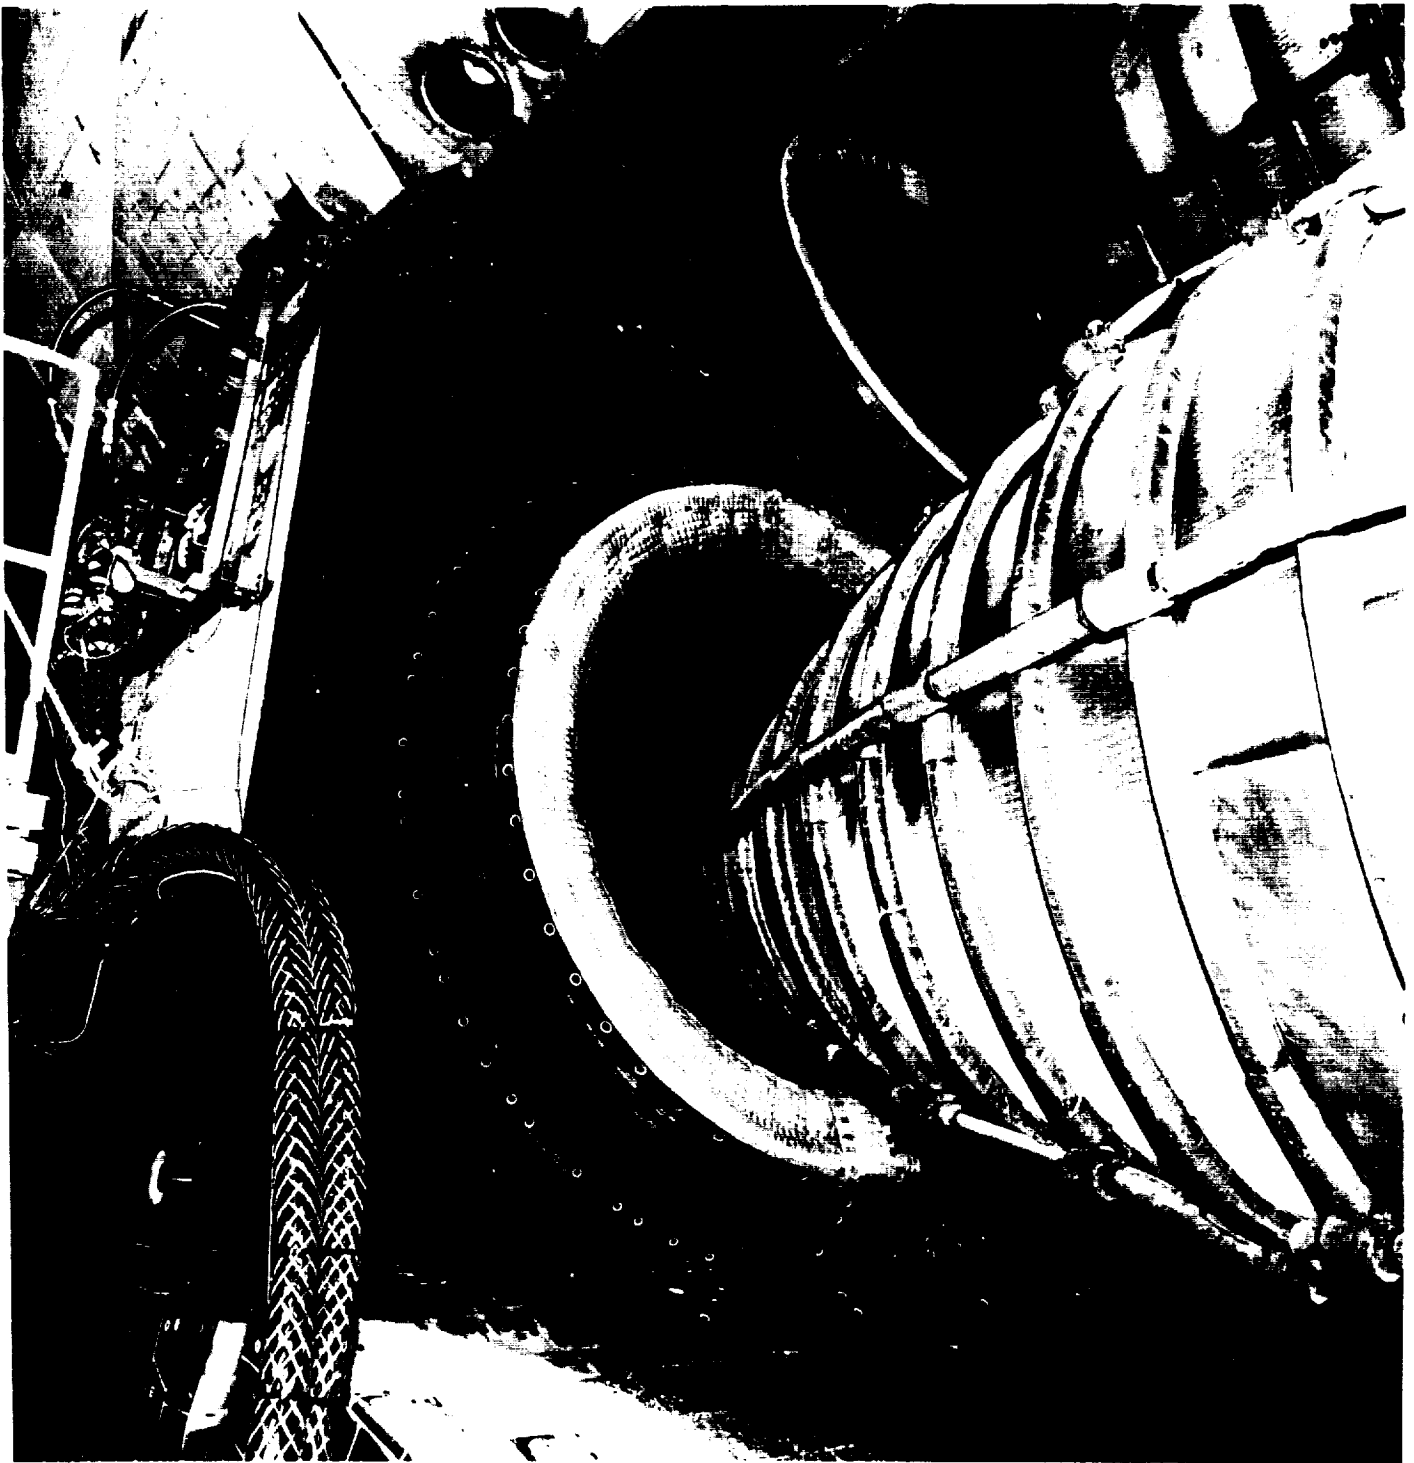
Photo 22: View of Base Heat Shield

All three Dome Mounted Heat Shield (DMHS) closeout blankets were in excellent condition with no missing material.

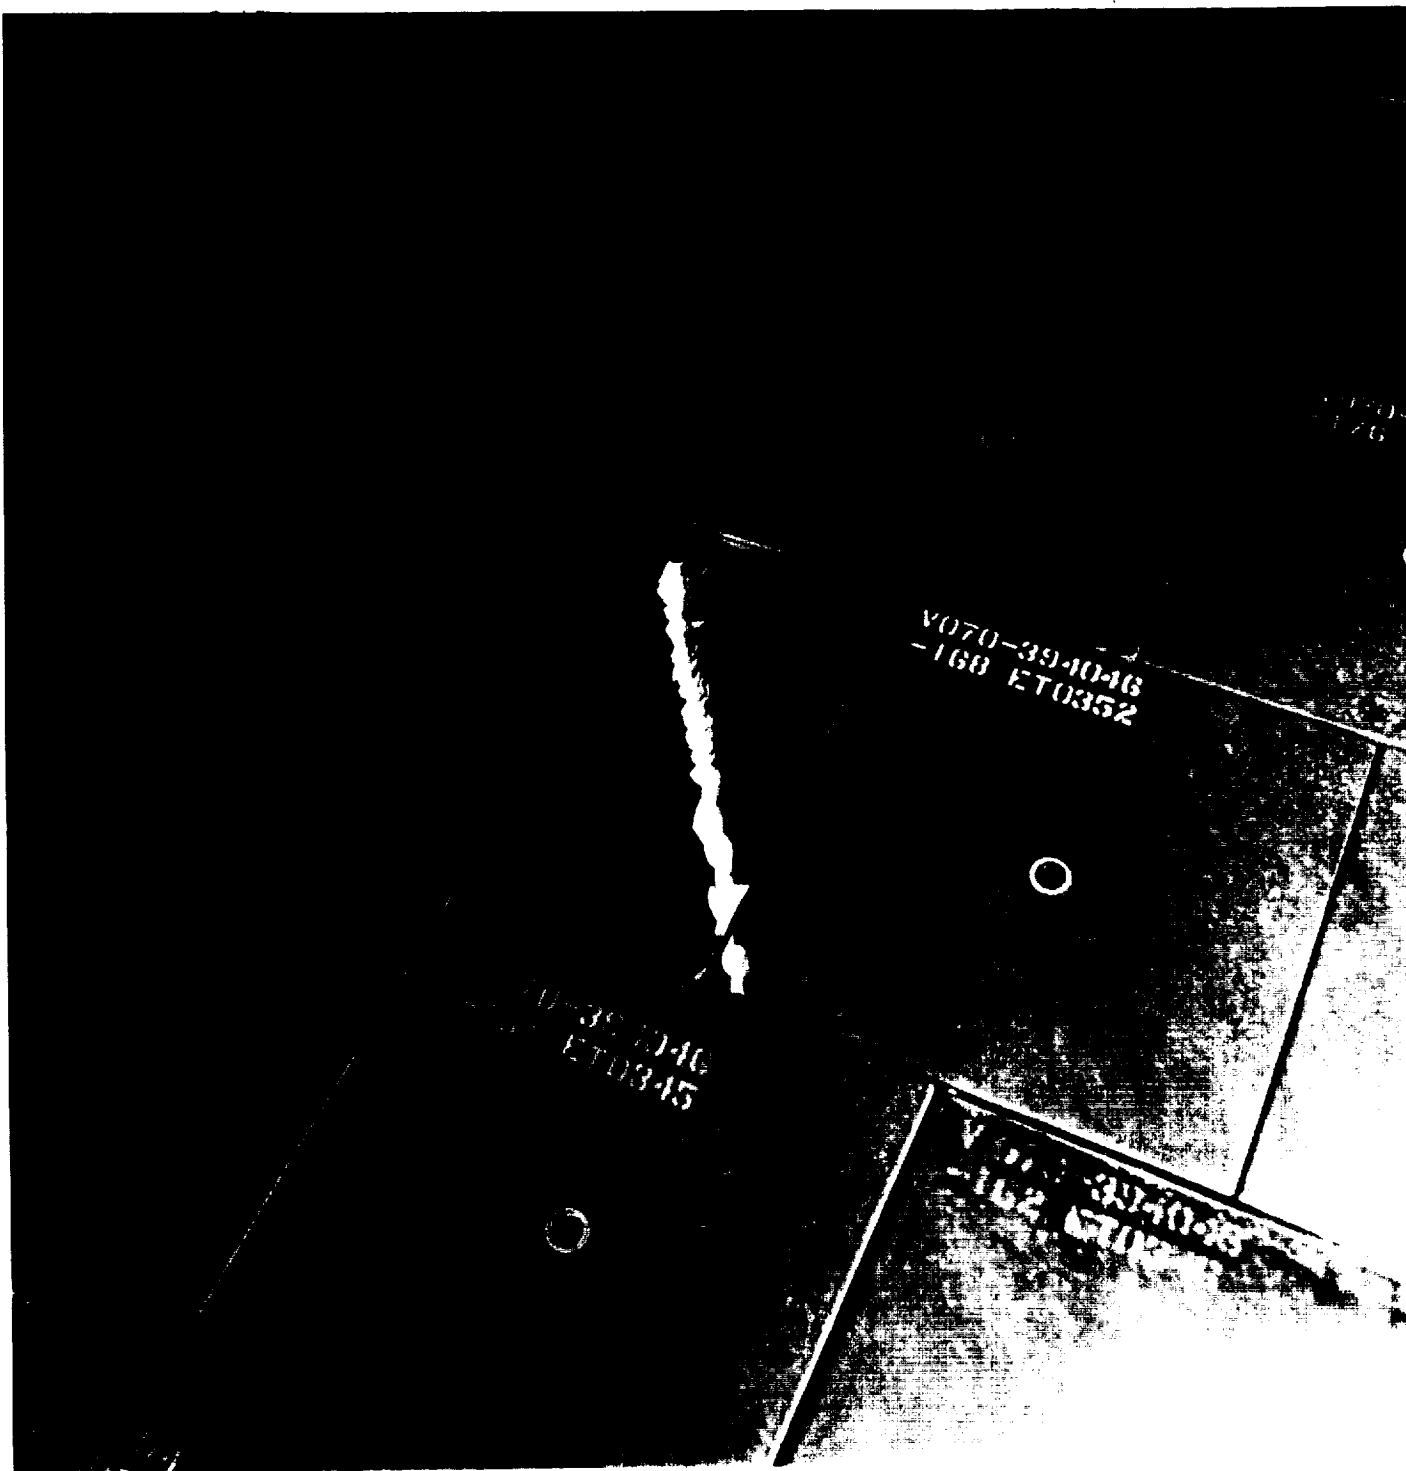
Photo 23: Lower Surface Tile Damage

The Orbiter lower surface sustained a total of 55 hits, of which 6 had a major dimension of 1-inch or larger. The largest lower surface tile damage site occurred approximately 15 feet forward of the RH MLG wheel well and measured 6.0-inches long by 0.375-inches wide by 0.25-inch maximum depth
